INSPECTING A CLASSIC BOREHOLE

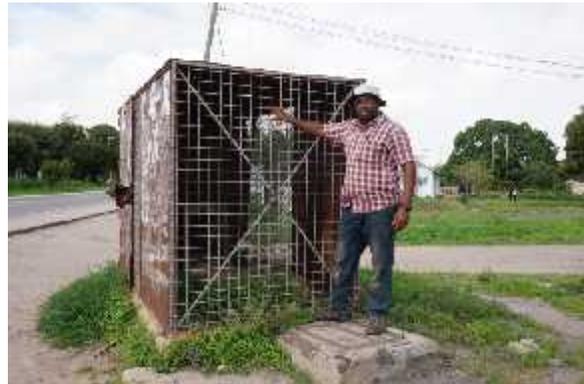
According to information we gathered, this borehole was drilled early in the 20th Century (prior to 1915) to provide water for steam locomotives passing through the Dodoma Railway Station. It had been used intermittently since and was thought to be exceptionally productive. The borehole site includes a security cage attached permanently to a concrete pad, a concrete base for a piston working head around the casing, and the engine base (engine long removed, more recently equipped with submersible pumps).

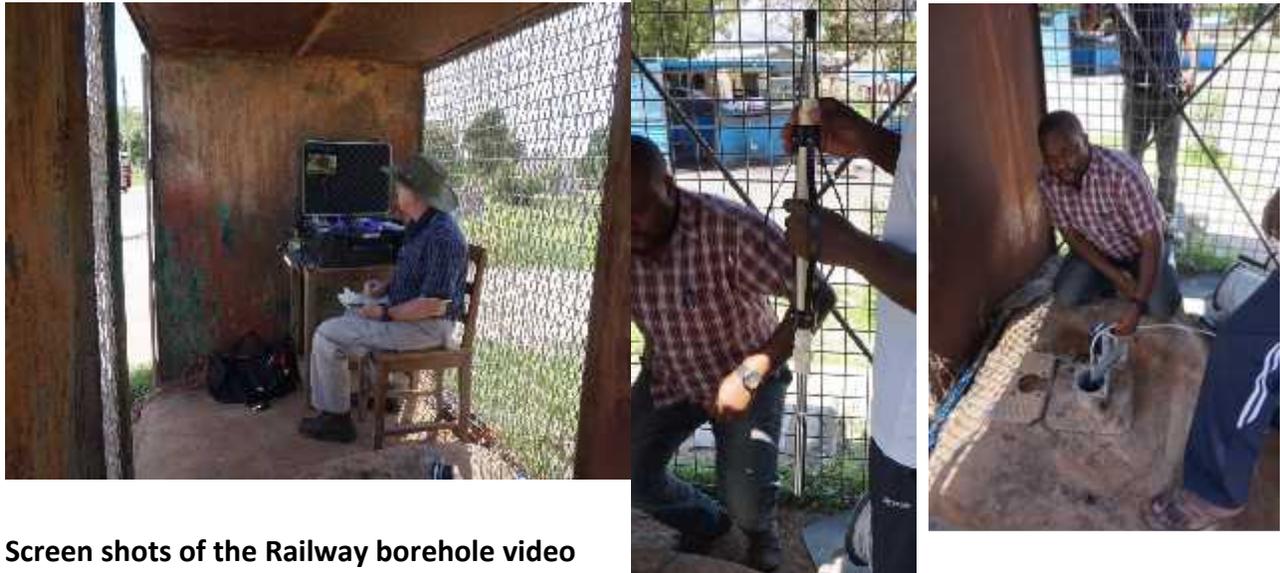
Using the Nano borehole video system (Allegheny Instruments)
